Problem OEM Damaged Cores!

Solution Wooden Cores!

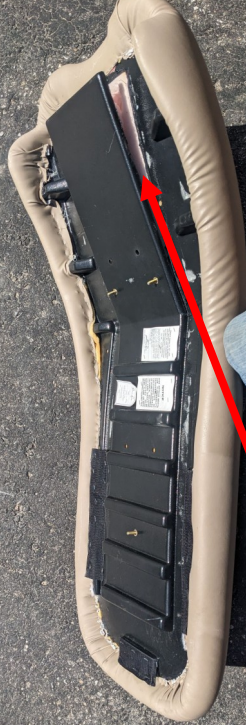
Original Pelton Crane SP3000 Seat Core

Once again the plastic that supports the weight of the patient has broken out

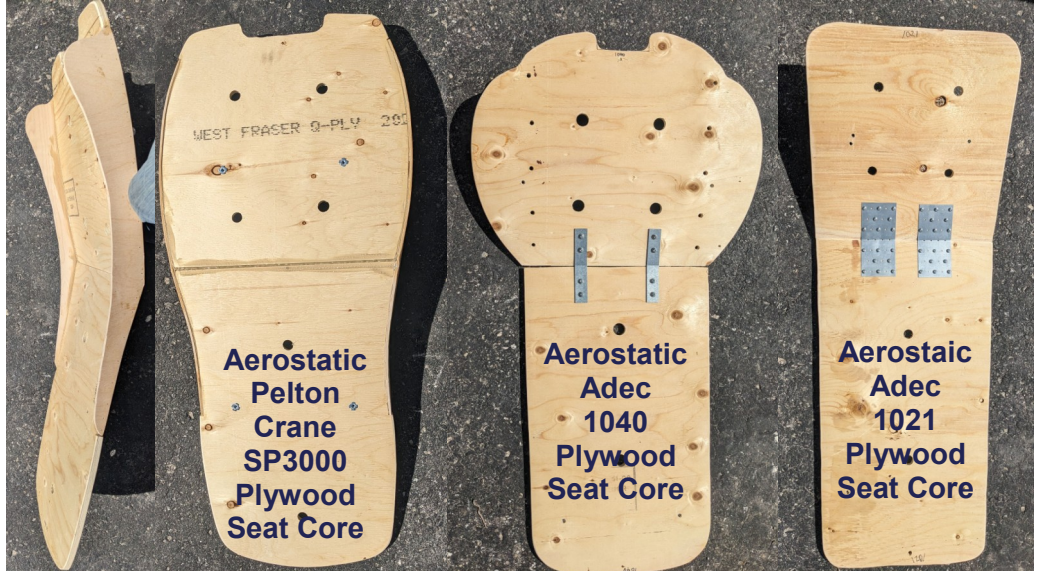
- Our cores are made from 5/8" Plywood for long life.
- We use metal tee nuts to receive the bolts and securely fix the core to the seat frame.
- We use metal brackets to join our plywood sections in a stable and durable manner.
- On the contoured cores we use plywood gussets glued with construction adhesive to the plywood sections to give the core strength and durability.

Aerostatic replaces all these types of plastic cores with new plywood cores. Our guarantee... "If the plywood cores break we will replace them FREE OF CHARGE"
